# Case Study

## Anglo American – Kumba Iron Ore Sishen Mine

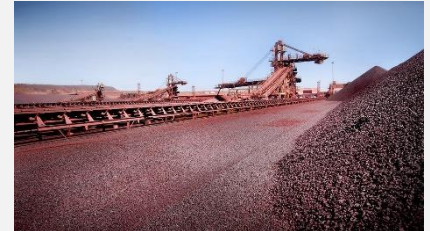
- 1400 conveyor belt started running skew towards the RHS (facing the head pulley). The skew movement was caused by the 1200 and 1300 feed belts' head chutes loading off-centre on the 1400. This resulted in the 1400 conveyor belt carrying more load on one side and shifting to one side, causing a skew movement.

- The constant shifting and running into the head chute structure caused the belt to flip and fold on its central axis, ending up in a circular profile moving over the pulley to the return side, where it got cut by the scraper.

- Immediate replacement of the belt
- New scrapers installed
- Belt tear sensors installed
- Shuttle structure repaired
- Skew limits installed
- Full audit conducted on 1200, 1300 and 1400 conveyors
- Location and direction of chutes on 1200 and 1300 corrected
- All head chutes repaired/refurbished
- Structure of 1400 straightened
- Shuttle structure upgraded
- Planned routine tasks for 1400 conveyor and head chute reviewed
- Compliance with escalation process reiterated and reinforced
